# The restoration of common reed on Windermere and Esthwaite's shores

## 'Linking Lakes' - UKILN Conference

Dr Mike Sturt, Technical Officer, SCRT

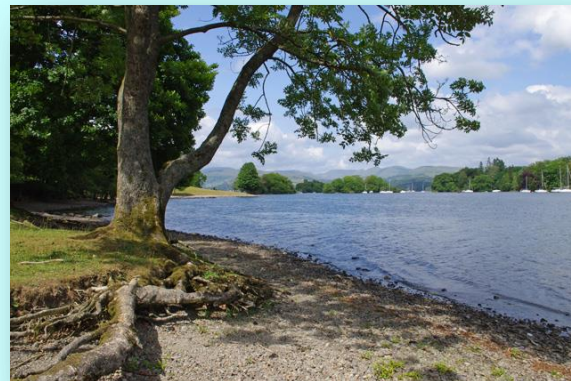
Prevent shoreline erosion

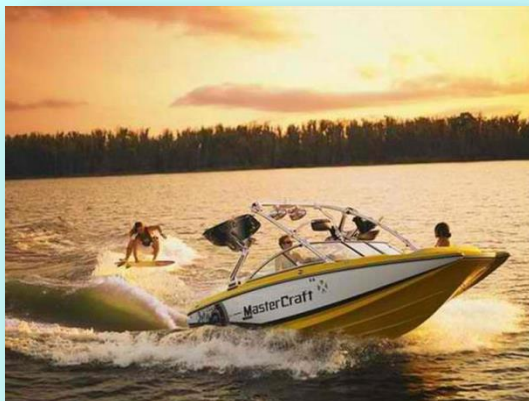
Boat wave wash

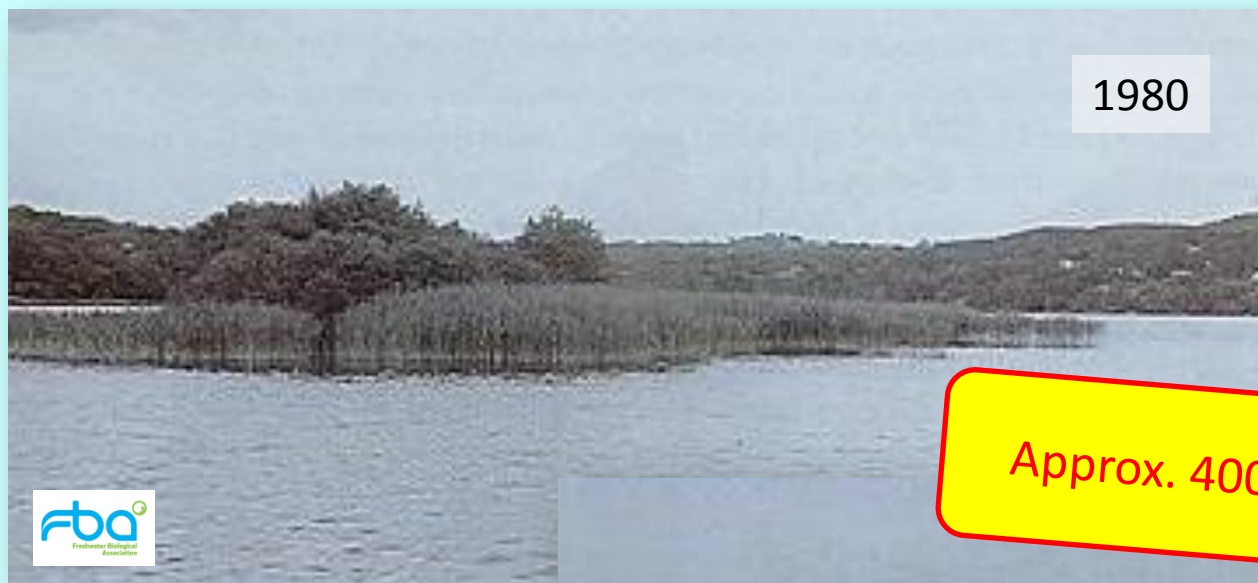
Approx. 4000m<sup>2</sup> lost

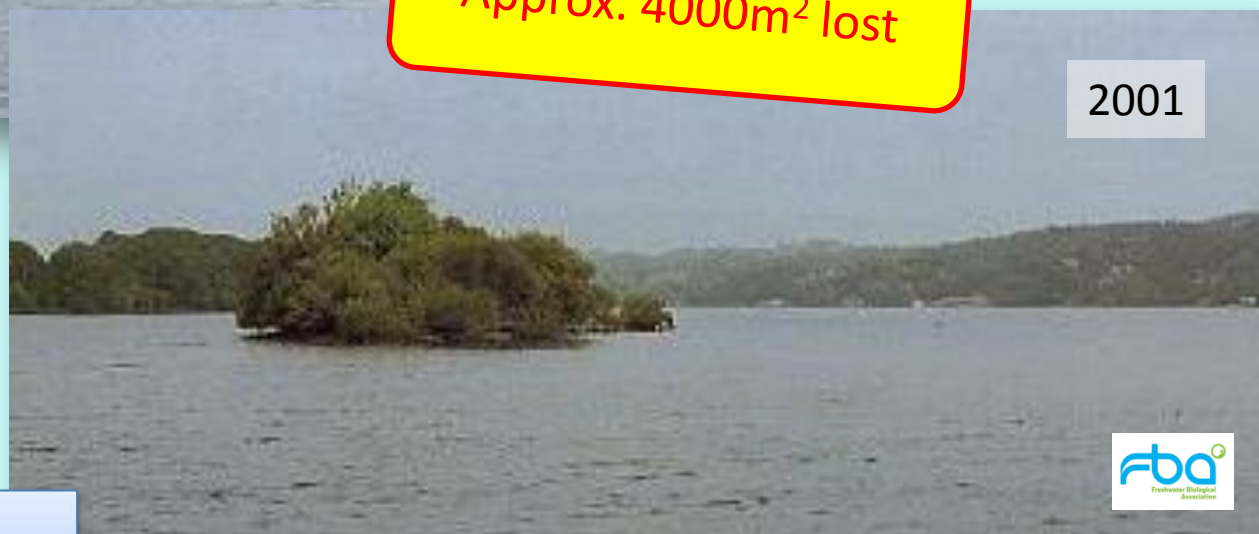
Grass Holme Island  
South Basin of Windermere

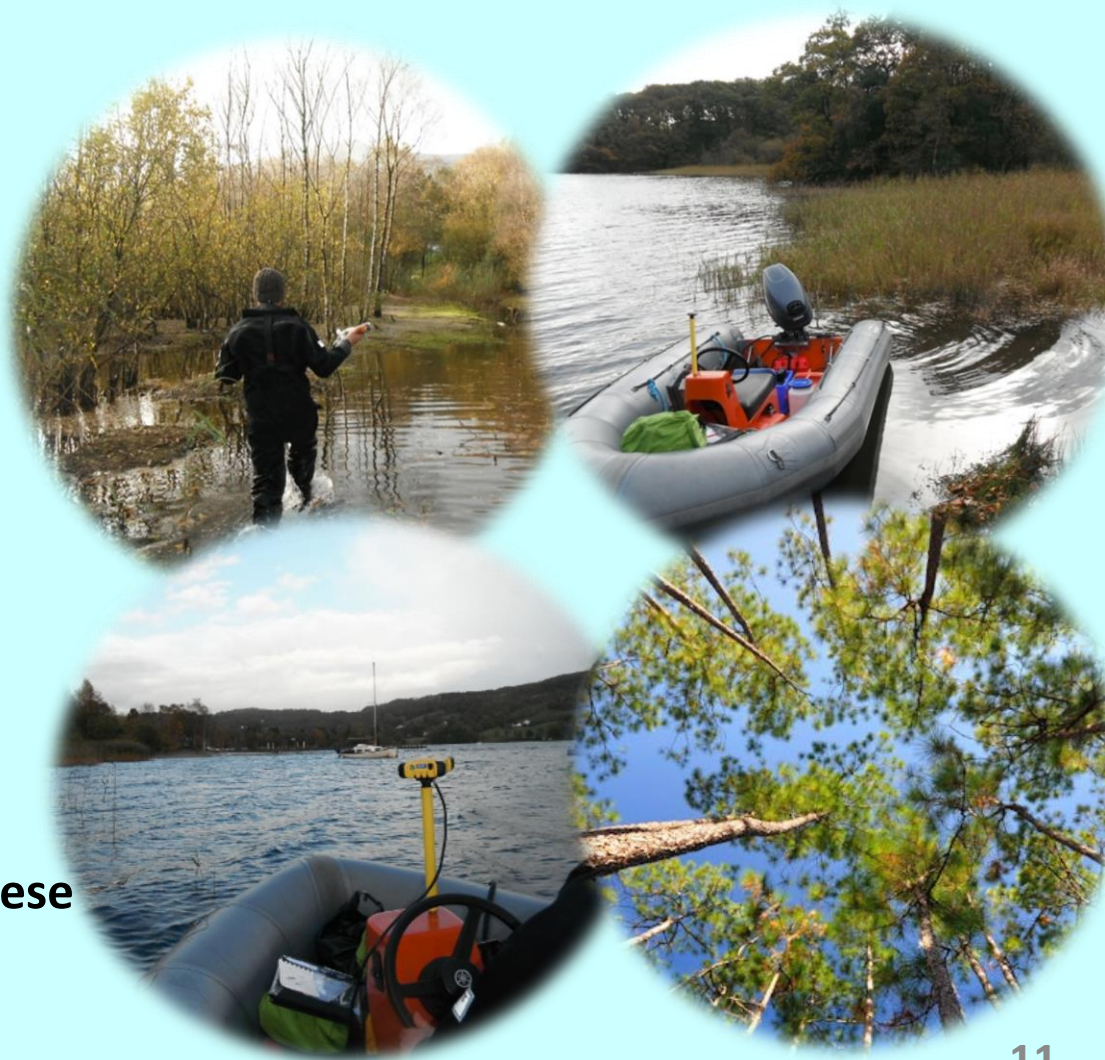
- Area: Laser range-finder
- Location: *d*GPS & maps
- Records of damage by geese
- Photographs
- Canopy cover
